USB Energy settings

Camera issues

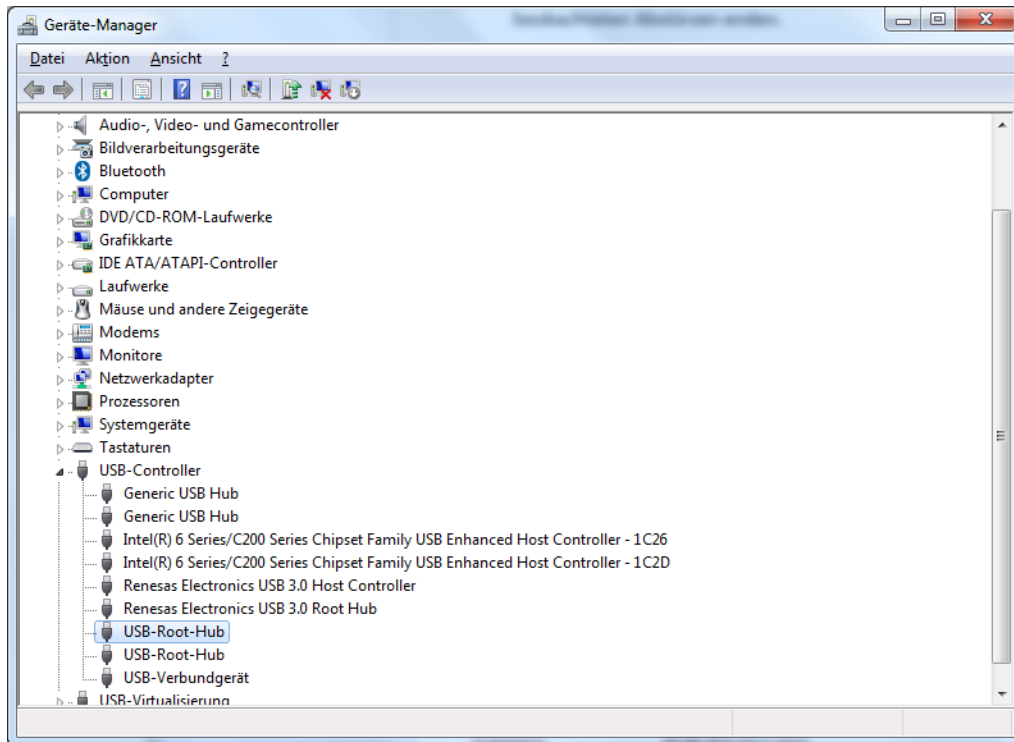
Open the Device Manager and select USB Root Hub.

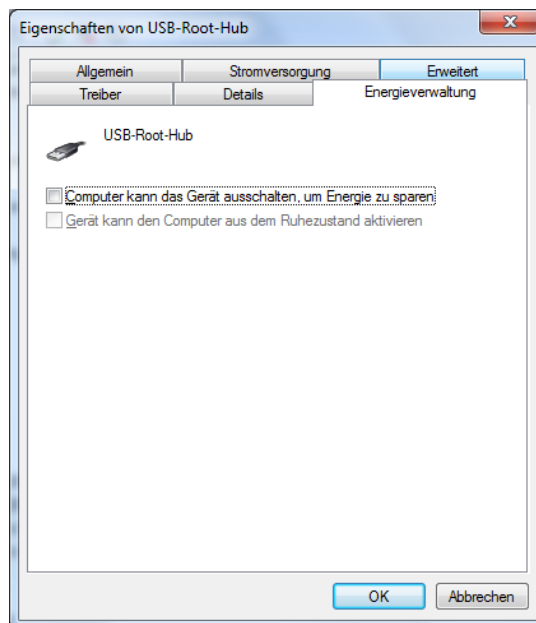
Go to the management of the hub with a right click and select 'Properties'. Then navigate to the tab labelled 'Power Management'.

Make sure that the box for 'Allow the computer to turn off this device to save power' is not checkmarked, in other words, that this function is disabled.

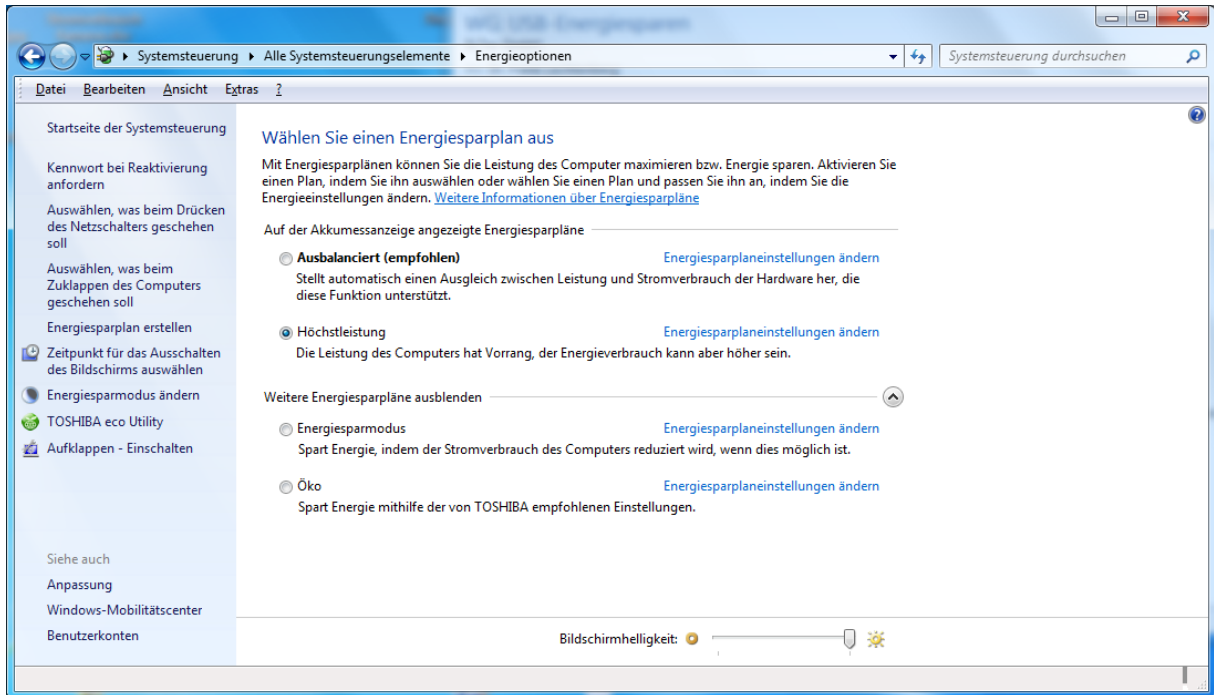
From the Control Panel, go to 'All Control Panel Items' and select 'Power Options'.

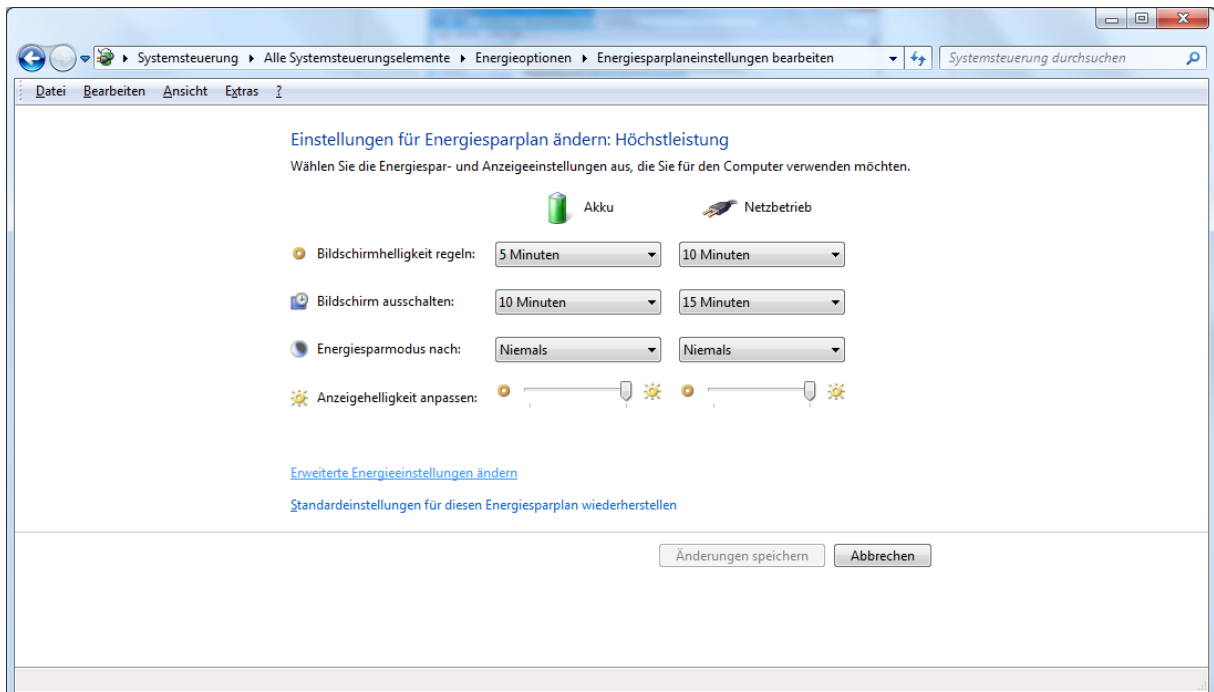
Go to the power plan selected by you and click on the 'Change plan settings' link.

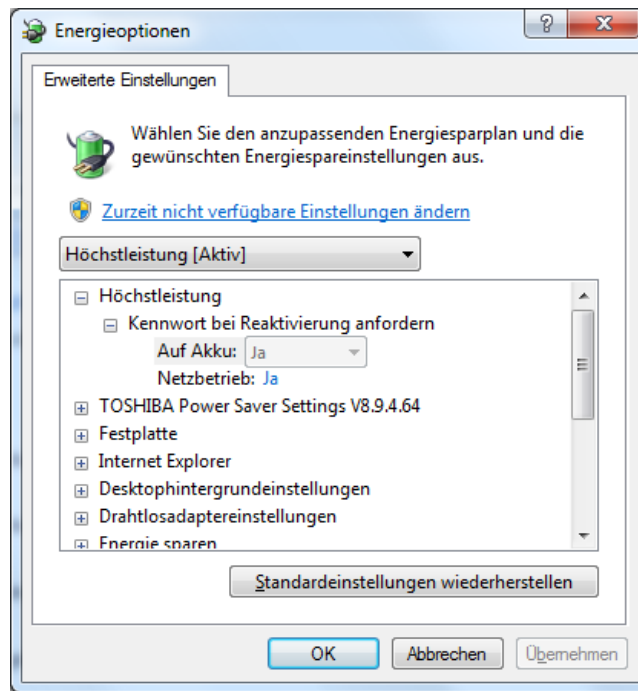
Navigate from there to 'Change advanced power settings'.

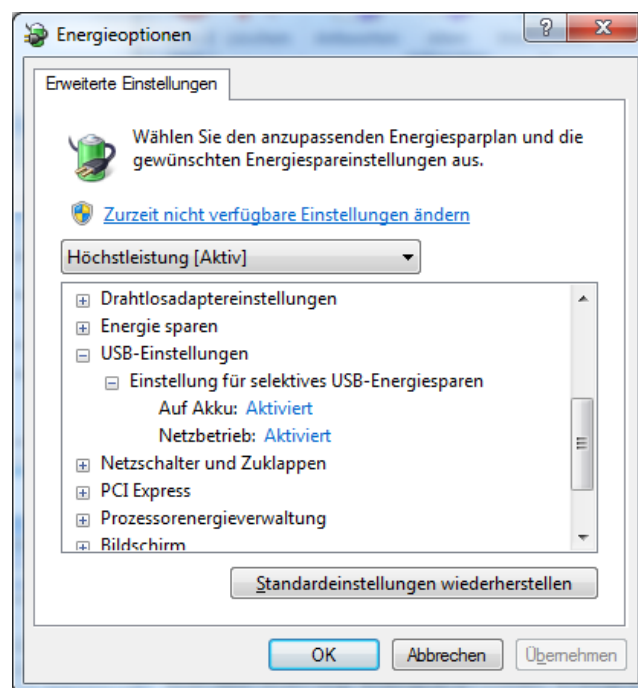
Scroll down to USB Settings and open the related submenu. Make sure that the settings for USB selective suspend setting are disabled. This means that in the following screen, you should be able to make changes.
